# Home Inspection Report

1000 SW Broadway Ave, Okeechobee , FL 34972

**Inspection Date:**

Thursday August 3, 2017

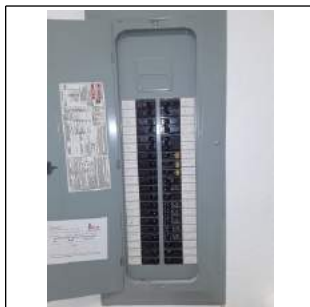
200 Amps: Cutler Hammer

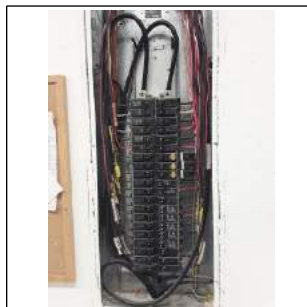
The breakers are in good physical condition

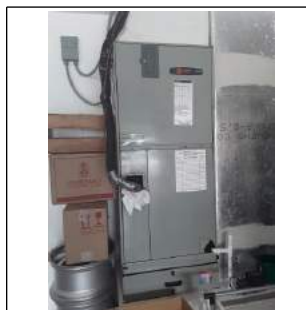
2005

The air conditioning system was cooling properly during the inspection

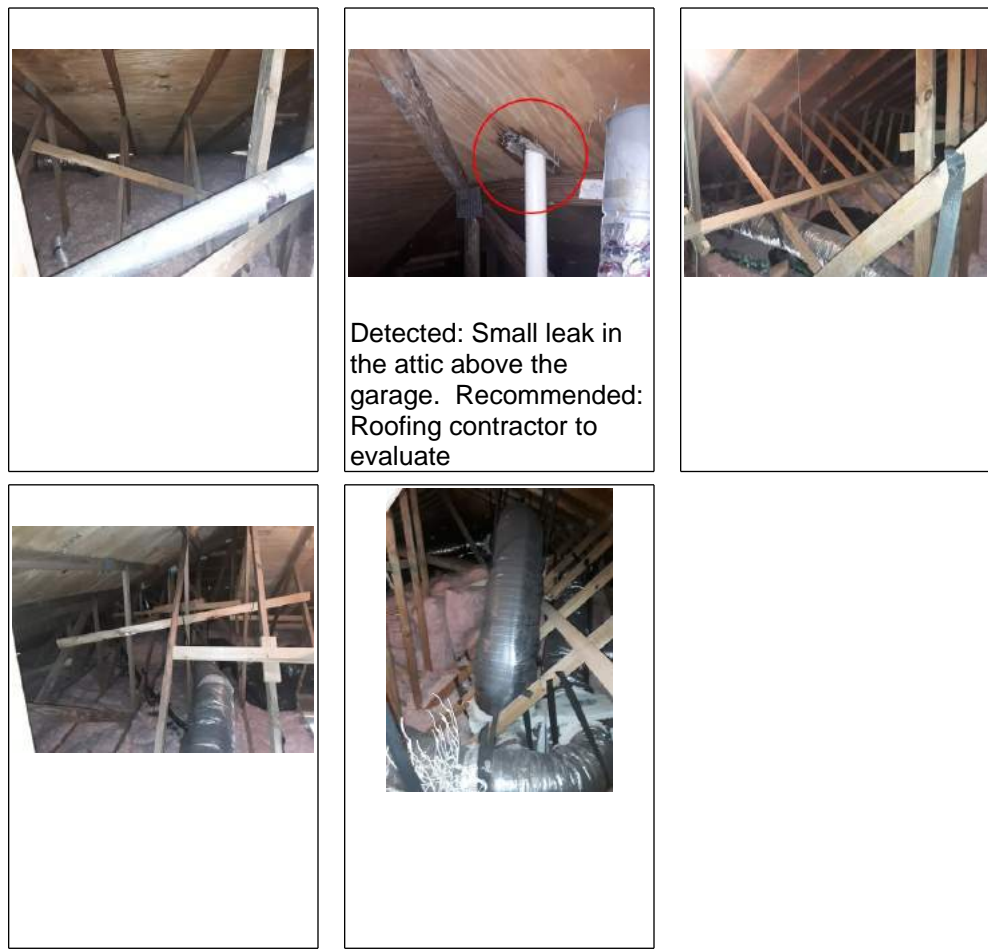
**Attic** • R30 Fiberglass in Main Attic

**General comments** Recommended: Roofing contractor to evaluate and repair the sheathing rot in the attic over the garage

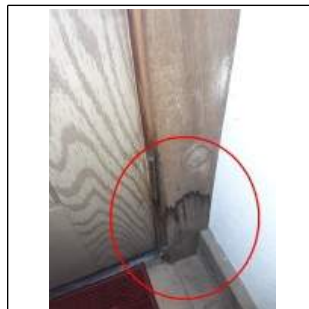
Front door moisture stains
